**PRELIMINARY GEOTECHNICAL ENGINEERING  
REPORT**

*NOTTINGHAM SOLAR FACILITY*

**Golder Associates Inc.**

July 16, 2021

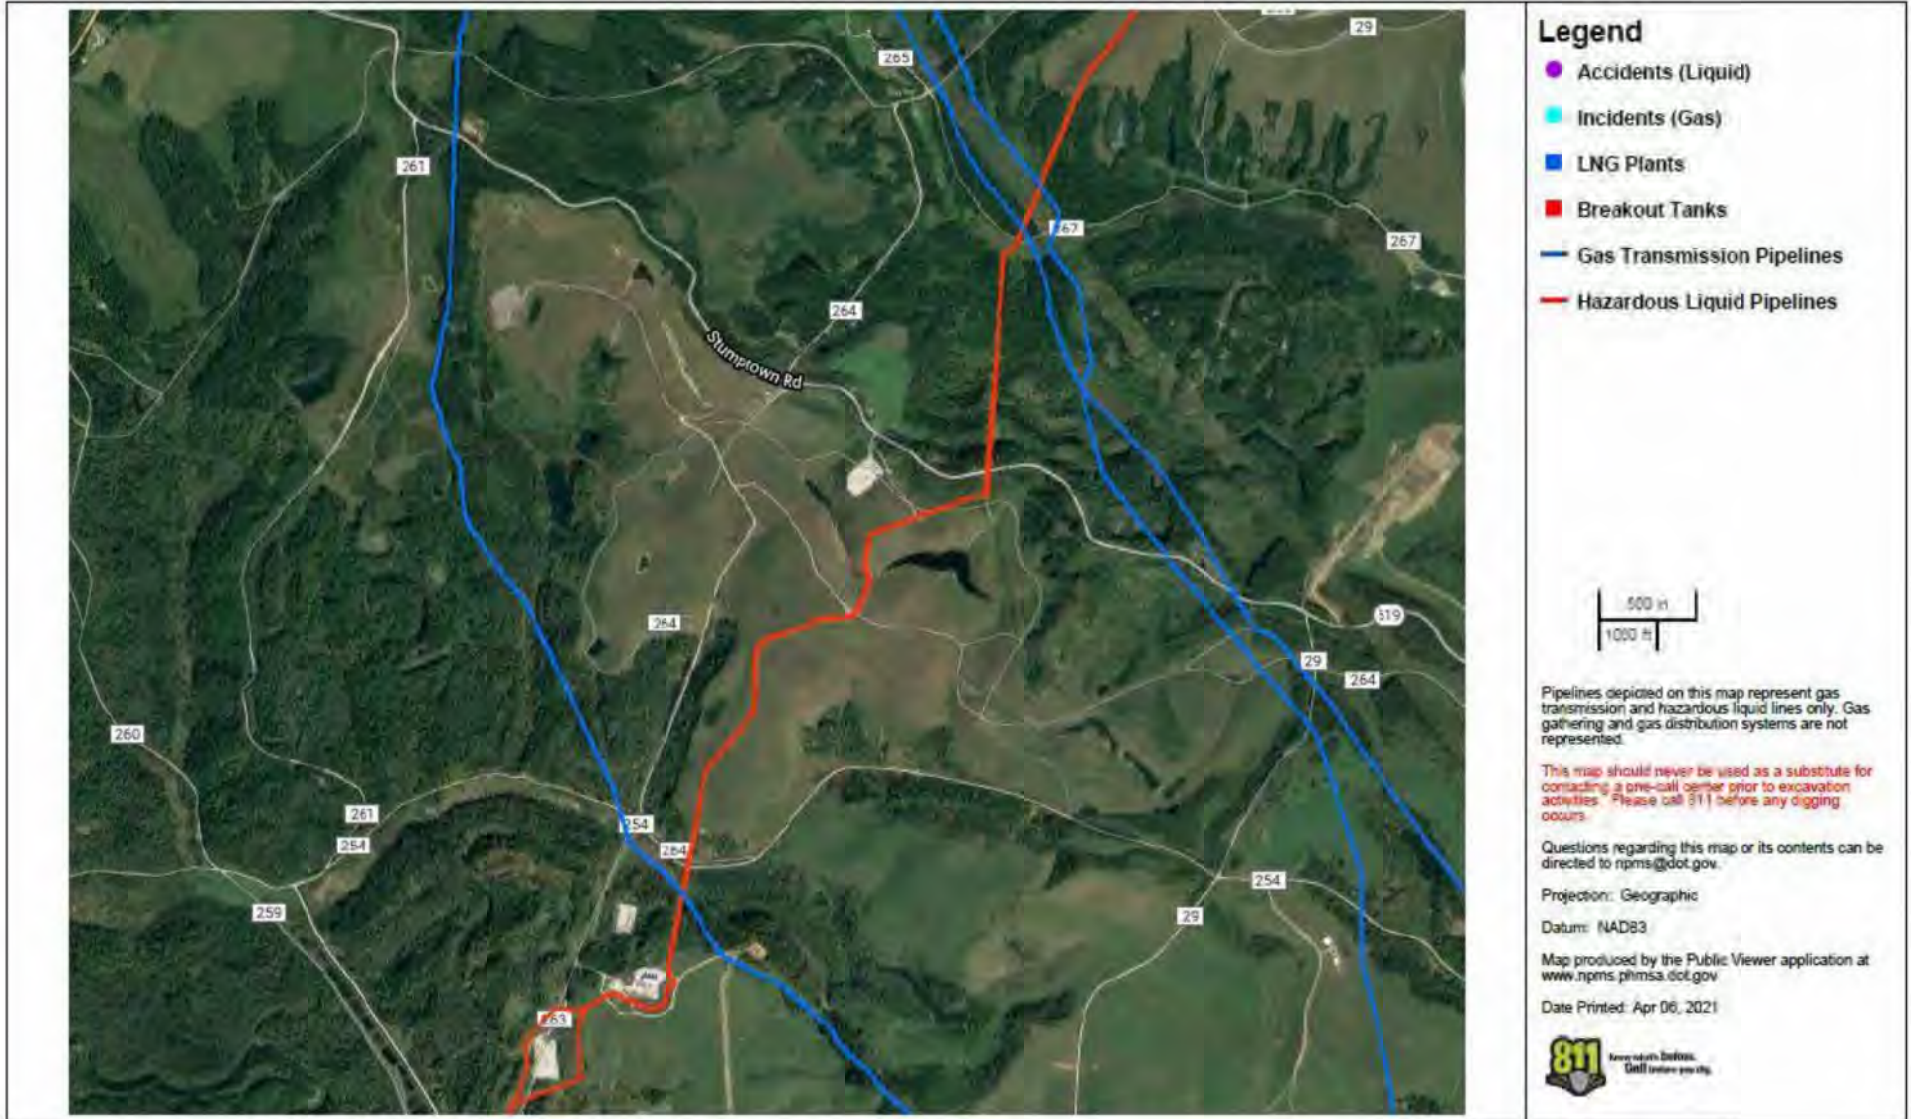
Figure 10 - National Pipeline Mapping System

- Additionally, multiple pipelines route through the backfilled material around the Site. The hazardous liquid pipeline that is mapped in Figure 10 intersects a backfilled highwall along a side slope, posing a potential area of stability concern.

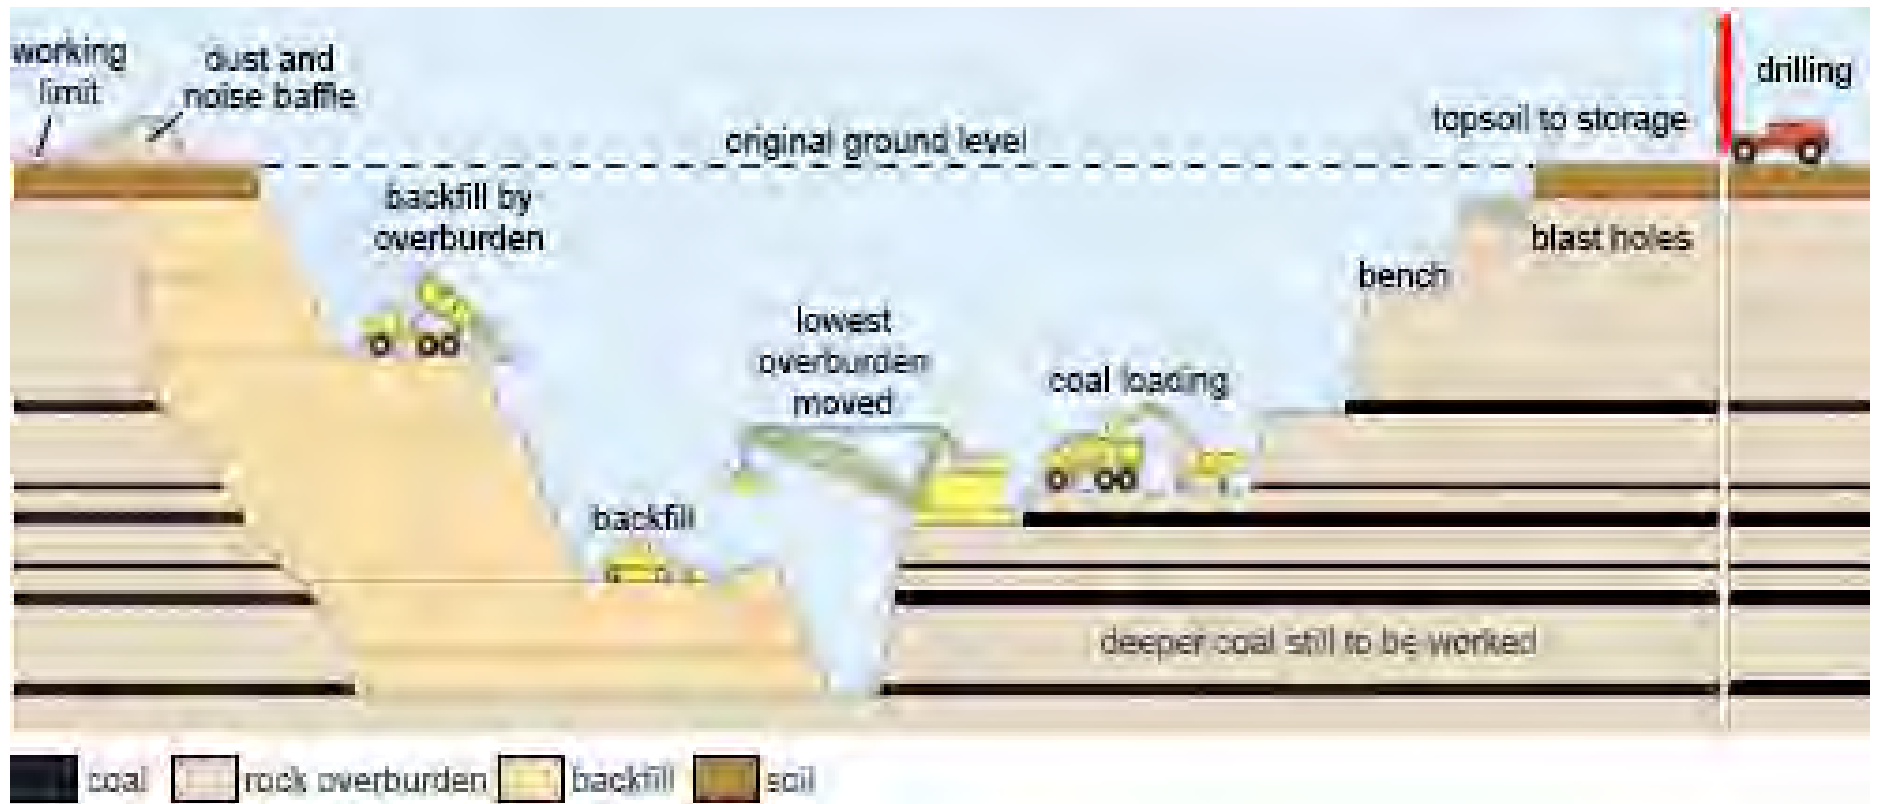
Figure 18 - Surface Mining Diagrammatic Section (Source: The Open University)
